<b>Subject:</b>  <b>AIR TEMPERATURE WILL NOT CHANGE</b>	<b>Bulletin No:</b> 07-003/15
	<b>Last Issued:</b> 11/17/2015

2014-15 Mazda3 (Japan built with manual A/C) with VINS lower than JM1BM\*\*\*\*\*247593 (produced before December 1, 2014)

2014-15 Mazda3 (Mexico built with manual A/C) with VINS lower than 3MZBM\*\*\*\*\*182009 (produced before January 1, 2015)

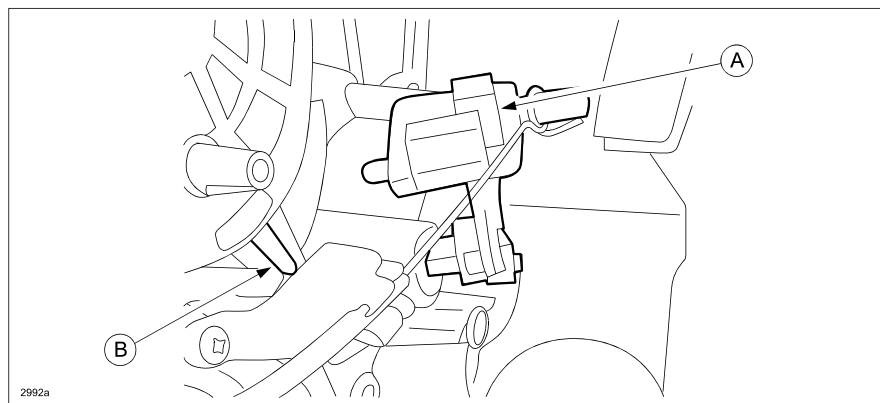
Some customers may complain about that air temperature from the air conditioner will not change by the air temperature control knob, and may be accompanied by some rattle noise from inside of the dash board. This concern may be caused by the temperature control link being pulled out of the HVAC housing. To correct the problem, the temperature control link has been modified.

1. Verify customer concern.
2. Refer to the instructions on MS3 online or the Workshop Manual (section 07-40 CLIMATE CONTROL UNIT REMOVAL/INSTALLATION [MANUAL AIR CONDITIONER]) and check that the MIX LINK (Air mix link/Temperature control link) (A) is properly connected to the MIX DOOR CRANK (B) and works while rotating the temperature control knob.

- a. If it works, this Service Bulletin does not apply. Refer to the instructions on MS3 online or Workshop Manual for troubleshooting and repair.
  - b. If the MIX LINK is detached, proceed to the next step.
3. Replace the MIX LINK with a modified one. Refer to MS3 online or the Workshop Manual (section 07-11 A/ C UNIT DISASSEMBLY/ASSEMBLY). Make sure that the MIX LINK is fitted in the groove of the MIX DOOR CRANK and will not come out with movement.
