© 2014 Mazda Motor of America, Inc.

Subject: BUZZING NOISE FROM STEERING COLUMN	Bulletin No: 09-013/14
	Last Issued: 02/21/2014

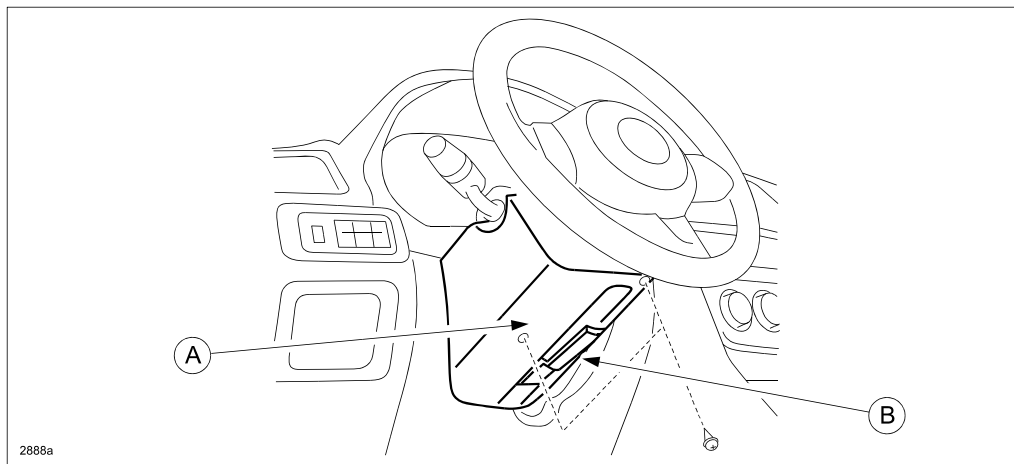
Some vehicles may experience a buzzing noise from the steering column when driving on rough roads or passing over speed bumps. This buzzing noise may be caused by the lower steering column cover (A) contacting the steering wheel adjustment lock lever (B). To correct the problem, felt is attached to the steering column cover.

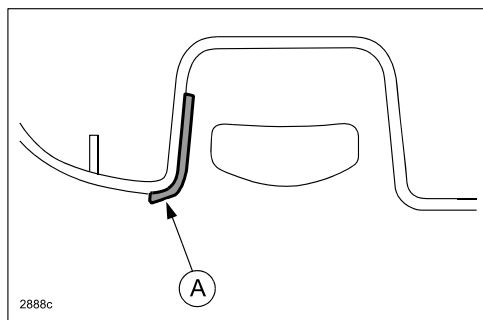
A-A cross section (Felt A)

A: End of edge

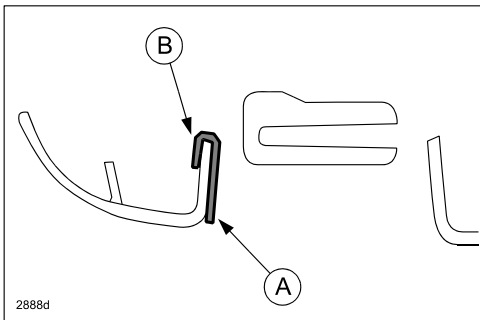
B-B cross section (Felt B)

A: End of edge; B: Fold back tip of the felt
