<b>Subject:</b>  CD PLAYER DISPLAY CONCERNS	<b>Bulletin No:</b> 09-032/14
	<b>Last Issued:</b> 09/16/2014

2014 Mazda3 vehicles (with MAZDA CONNECT and CD player) with VINS lower than JM1BM\*\*\*\* \*\* 154022 (produced before December 01, 2013)

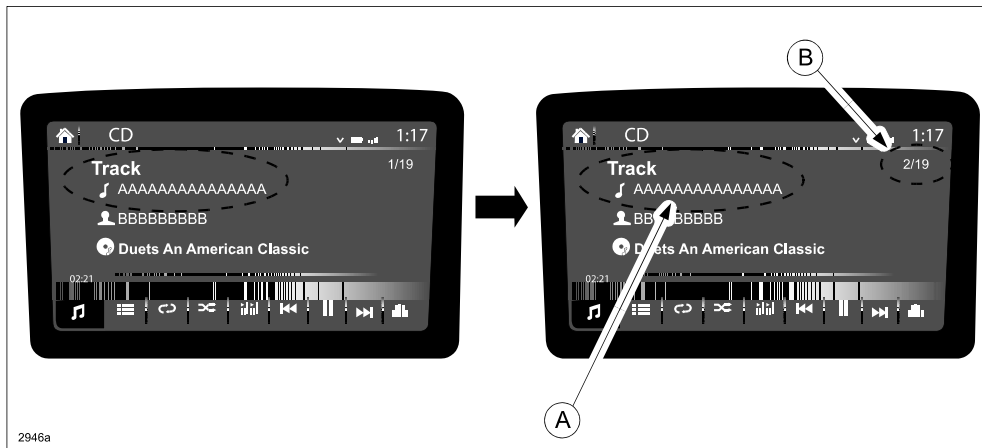
Symptom 1: The song title on the CD display (A) does not change when it goes to the next song. However, the track number (B) changes

This is caused by improper software of the CD player. The software of CD player has now been changed to correct this issue.

Customers having this concern should have their vehicle repaired using the following repair procedure.
