Subject: CHECK ENGINE LIGHT ON WITH DTC P0421	Bulletin No: 01-010/16
	Last Issued: 04/07/2016

Some vehicles may experience the check engine light on with DTC P0421:00 (Catalytic converter system) without experiencing poor engine performance or misfire (Mitsubishi PCM only).

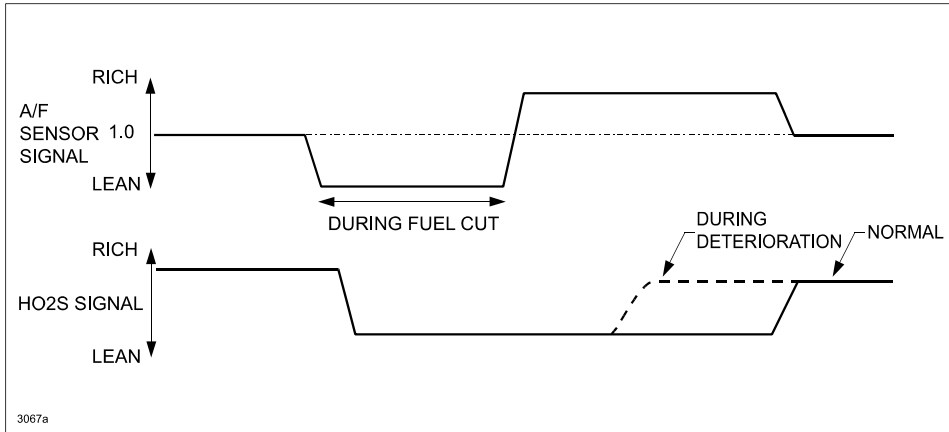
- If the catalytic converter purification characteristic deteriorates, the amount of the time until the HO2S detects the voltage on the rich side is shorter compared to the normal purification characteristic as shown. The PCM detects a catalytic converter malfunction using this characteristic.

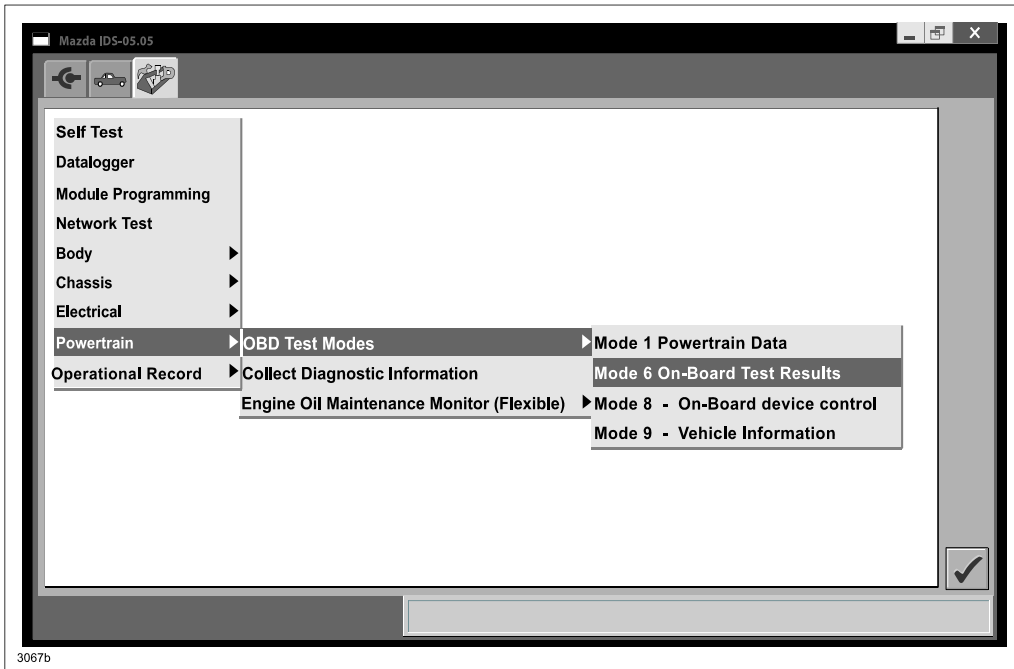
1. Verify the condition of the Warm Up Three-Way Catalytic Converter (WU-TWC) by checking the value “Catalyst monitor bank 1” on MODE6 with M-MDS.
 - a. Go to Powertrain => OBD Test Modes => Mode6 On Board Test Results
