Subject: CHECK ENGINE LIGHT ON WITH DTC P2610 AND P2507	Bulletin No: 01-018/15
	Last Issued: 08/06/2015

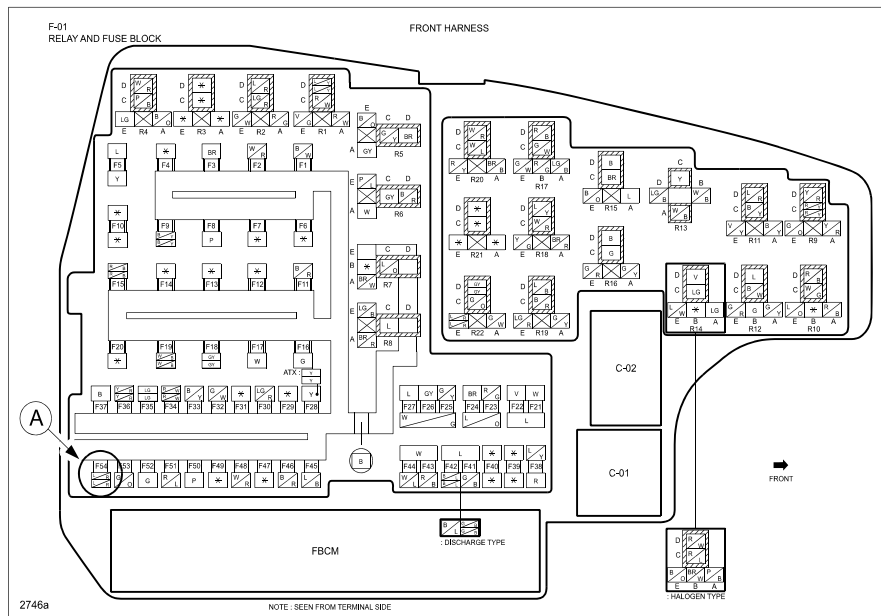
Some vehicles may experience the CHECK ENGINE LIGHT ON with DTC P2610 and P2507 stored in memory after engine start and room fuse 15A (A) removed.

- P2610:00: Instrument cluster internal engine off timer performance problem
- P2507:00: PCM battery voltage low input

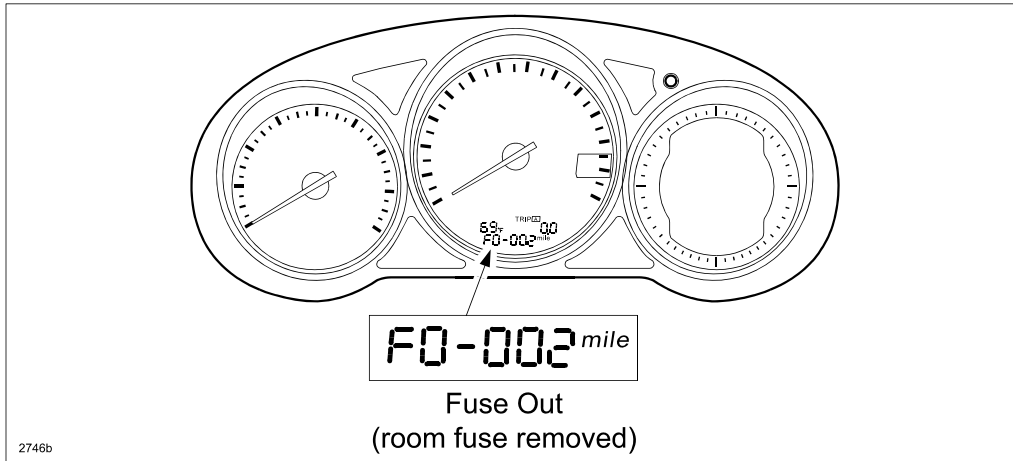
NOTE: The odometer will display "F0-002" during transport mode (room fuse 15A removed). Transport mode is canceled when room fuse 15A is installed or the vehicle odometer is more than 12.4mi (20km).
