Subject: COMMANDER SWITCH DROPS INTO CENTER CONSOLE	Bulletin No: 09-009/14
	Last Issued: 01/28/2014

2014 Mazda3 with VINs lower than JM1BM*****142131 (produced before November 6, 2013)

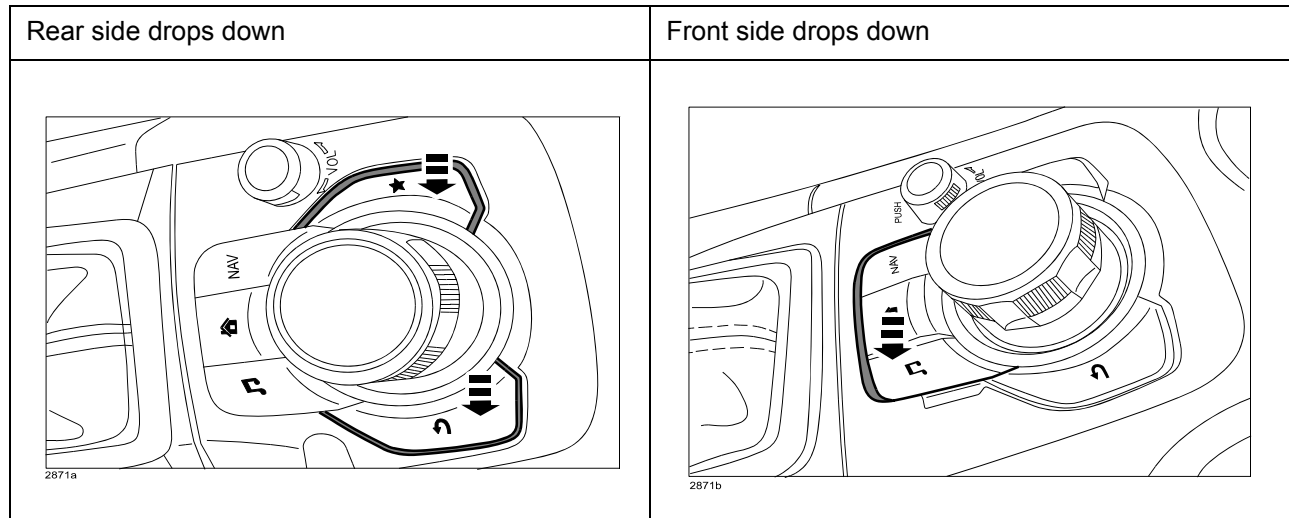
Some vehicles may experience a condition where the commander switch drops down from the panel.

1. Verify customer concern.
2. Replace the commander switch with a modified one according to the instructions on MS3 online or the Workshop Manual (section 09-20 COMMANDER SWITCH REMOVAL/INSTALLATION).
3. Verify repair.

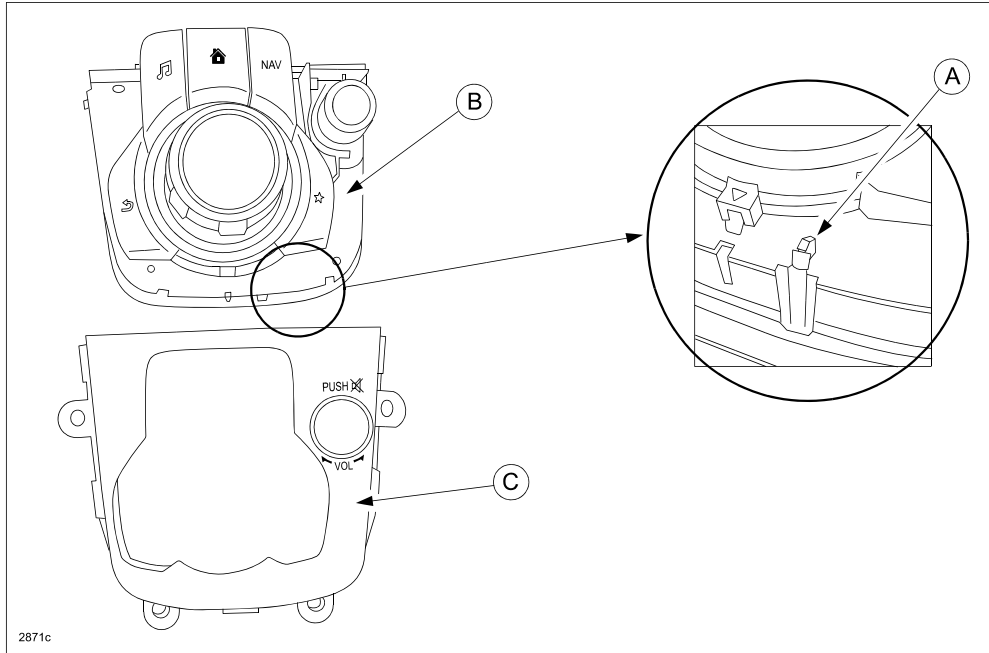
Damage to the hook(s) (A) securing the commander switch (B) to the frame (C) is caused by an excessive vertical force. To correct the problem, pieces of non-woven fabric have been added to the commander switch to increase the load capacity.
