<b>Subject:</b>  <b>CORROSION AROUND SPOT WELDS IN TRUNK OPENING</b>	<b>Bulletin No:</b> 09-011/16
	<b>Last Issued:</b> 02/23/2016

2014-15 Mazda3 vehicles with VINs lower than JM1BM\*\*\*\*\*211783 (produced before May 29, 2014)

2014-16 Mazda6 vehicles with VINs lower than JM1GJ\*\*\*\*\*416327 (produced before March 2, 2015)

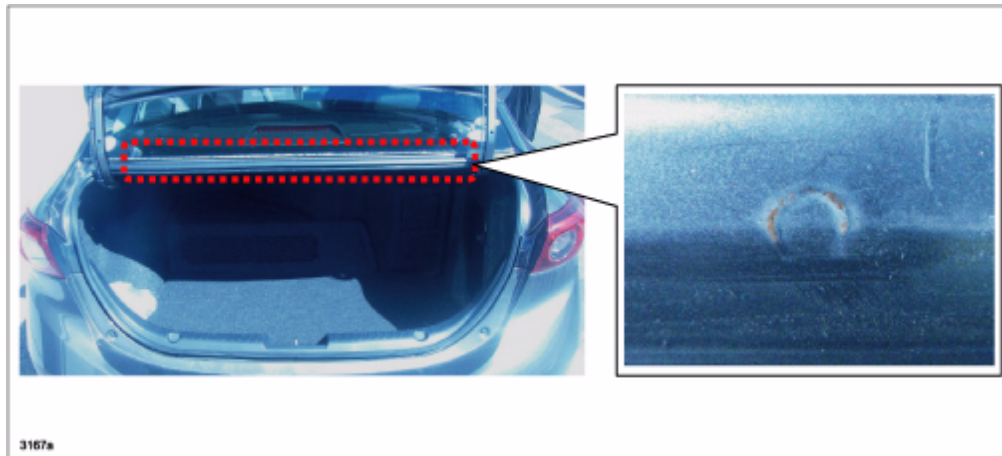
Some vehicles may exhibit corrosion around the spot welds in the trunk opening under the rear window. This is caused by insufficient paint thickness at the spot welds. To correct the problem, the paint thickness has been improved.

1. Verify customer concern.
2. Repair the rust damage on the panel.
3. Verify repair.
