| Subject: LIFTGATE HARD TO LATCH IN COLD TEMPERATURES BELOW FREEZING | Bulletin No: 09-020/15 |
| | Last Issued: 05/25/2015 |

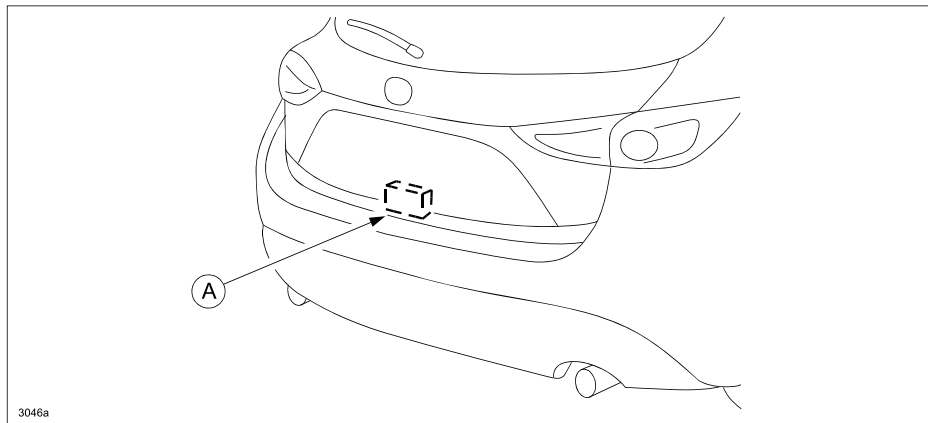
Some vehicles may exhibit a condition in extremely cold temperatures (below freezing) where the hatchback will not latch (half latch) when closing. This is caused by the stopper rubber, a component of the liftgate latch and lock actuator (A), hardening when the temperature drops below freezing. The stopper rubber has now been improved to eliminate this concern.

1. Verify customer concern.
2. Replace the liftgate latch and lock actuator with a modified one. Refer to MS3 online instructions or Workshop Manual section 09-14.
 - For Mazda3: LIFTGATE LATCH AND LOCK ACTUATOR REMOVAL/INSTALLATION.
 - For CX-5: LIFTGATE LATCH AND LOCK ACTUATOR REMOVAL/INSTALLATION.
3. Verify repair.
