© 2014 Mazda Motor of America, Inc.

Subject: MASTER AND CHARGING SYSTEM WARNING LIGHTS ARE ON AND INSTRUMENT CLUSTER WARNING MESSAGE IS DISPLAYED (DTC P1794)	Bulletin No: 01-001/14
	Last Issued: 08/05/2014

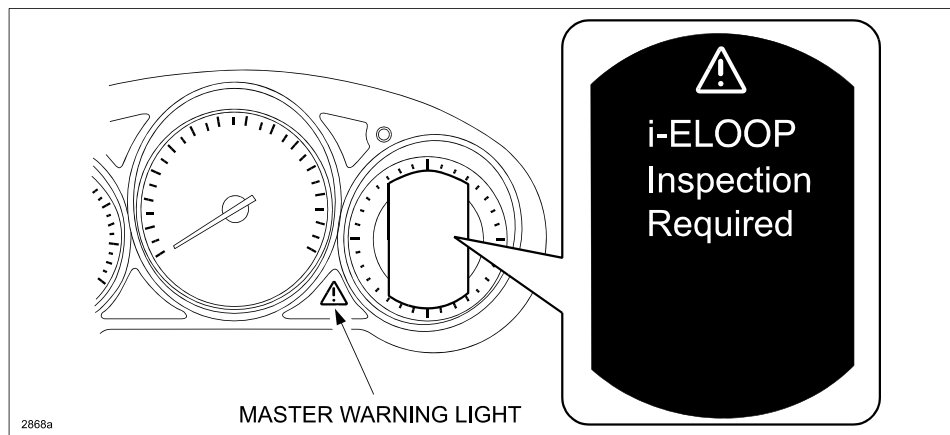
- a. Warning message “i-ELOOP Malfunction” (Mazda3) or “i-ELOOP Inspection Required” (Mazda6) is displayed in the instrument cluster information display while driving.
- b. The master warning light and charging system warning light illuminate.

- c. DTC P1794:00 (Capacitor (i-ELOOP) system: Capacitor (i-ELOOP) malfunction) is stored in PCM memory. Customers having this concern should have their vehicle repaired using the following repair procedure.

1. Verify DTC P1794:00 is stored in PCM memory.
2. Select M-MDS initial screen > "Datalogger" > "Module" > "PCM" > PID "CAP_SYS_16" and read the value.
3. Does the "CAP_SYS_16" show ON?
 - Yes - Proceed to step 4.
 - No - This service bulletin does not apply. Refer to MS3 online or Workshop Manual (section 01-02 DTC P1794:00 [SKYACTIV-G 2.5]).
4. Reboot the IDS to clear memory before reprogramming.
5. Using IDS 91.03 or later software, reprogram the PCM to the latest calibration following the "Module Reprogramming" procedure.

6. After performing the PCM reprogramming procedure, verify the repair by starting the engine and making sure there are no MIL illumination or abnormal warning lights present.
