Subject: MIL ON WITH DTC P2610	Bulletin No: 01-001/13
	Last Issued: 09/25/2013

2013-2014 CX-5

2014 Mazda6

2014 Mazda3

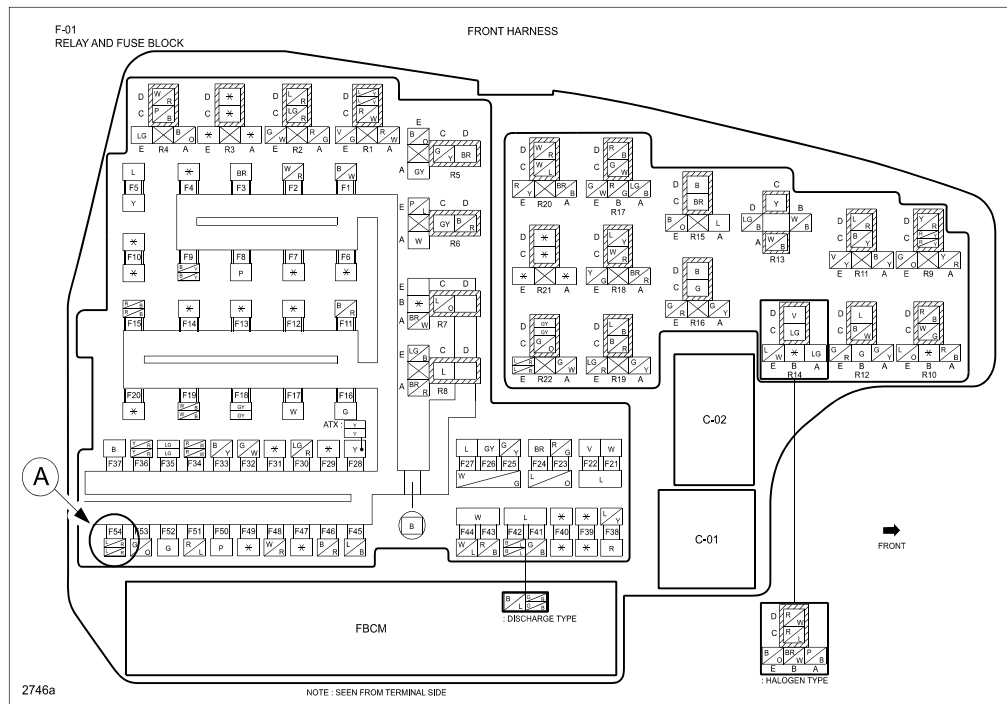
Some vehicles may experience MIL illumination with DTC P2610 (Instrument cluster internal engine off timer performance problem) stored in memory after engine start and room fuse 15A (A) removed.

1. Verify DTC P2610 is stored in PCM memory.
2. With the ignition off, install ROOM fuse 15A.
3. Clear DTC P2610 from PCM memory using IDS.
4. Verify no other DTCs are stored in memory. If so, troubleshoot them according to the MS3 online instructions or Workshop Manual.

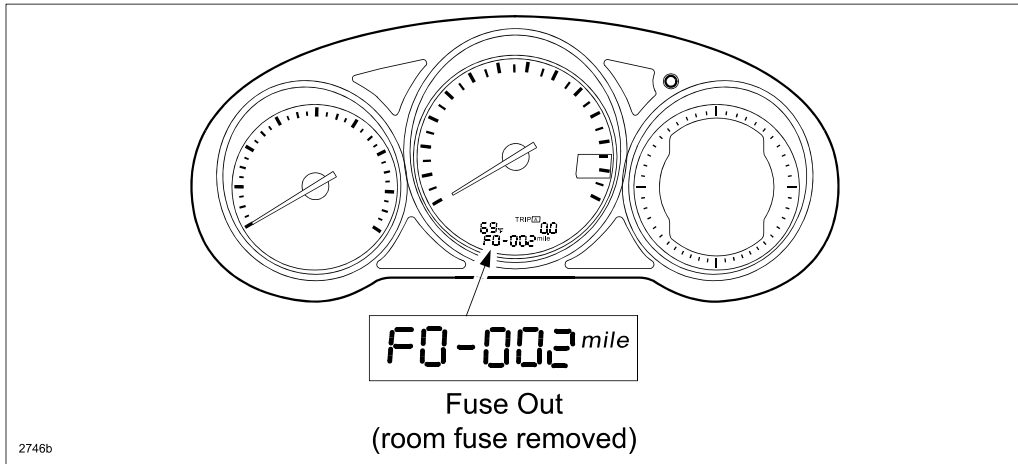
NOTE: The odometer will display “F0-002” during transport mode (room fuse 15A removed). Transport mode is canceled when room fuse 15A is installed or the vehicle odometer is more than 12.4mi (20km).
