Subject: MULTIPLE ELECTRICAL MALFUNCTIONS AFTER BODY REPAIR	Bulletin No: 09-022/14
	Last Issued: 05/30/2014

2013-2015 CX-5
2014 Mazda3
2014-2015 Mazda6

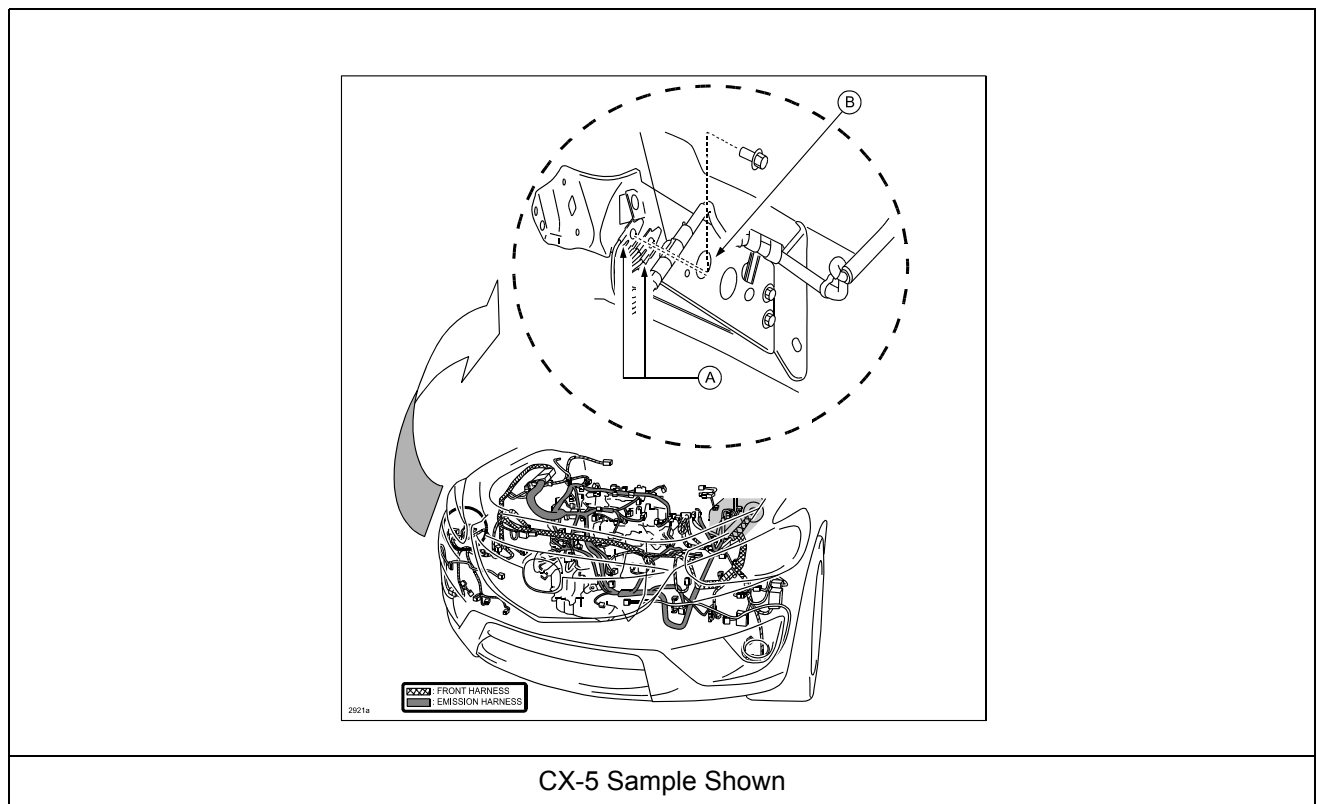
Some customers may experience an electrical malfunction after a vehicle body repair. The newly painted fender stay (B) may be causing a poor front harness (A) ground connection.

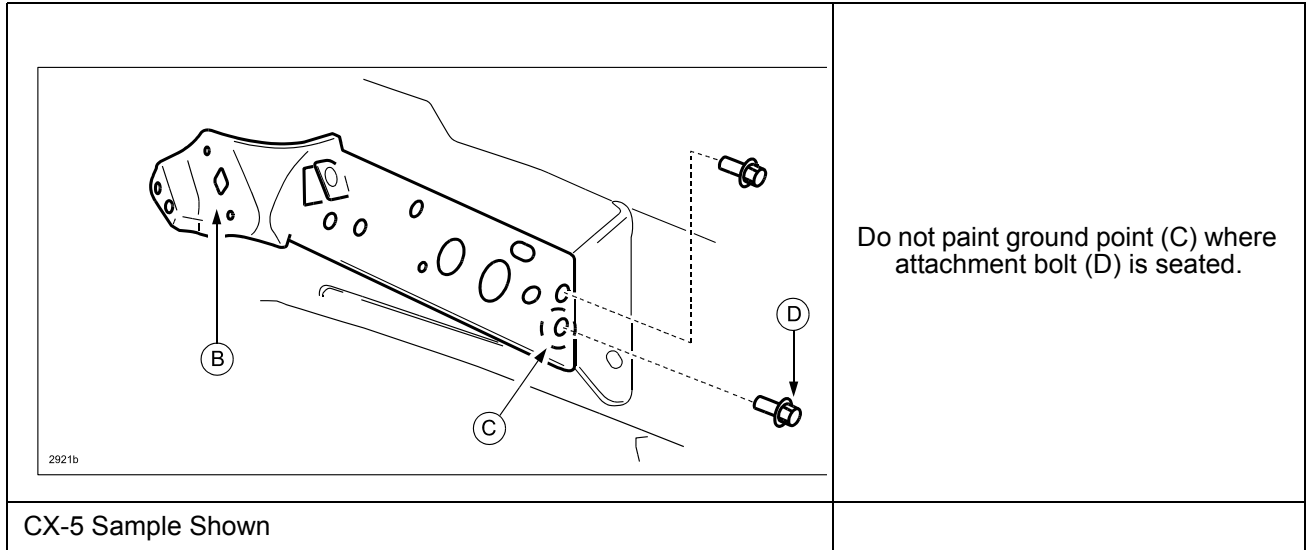
The front fender stay (B) newly painted surface at ground point (C), where attachment bolt (D) is seated, may create a poor front harness ground connection.

Customers concern can be resolved by sanding off paint at ground point (C) where attachment bolt (D) is seated. After installing the bolt (D), apply touch-up paint to the exposed base material area of the front fender stay.
