Subject: NO COOL AIR FROM AIR CONDITIONER (LEAK FROM EVAPORATOR)	Bulletin No: 07-002/14
	Last Issued: 10/23/2014

APPLICABLE MODEL(S)/VINS

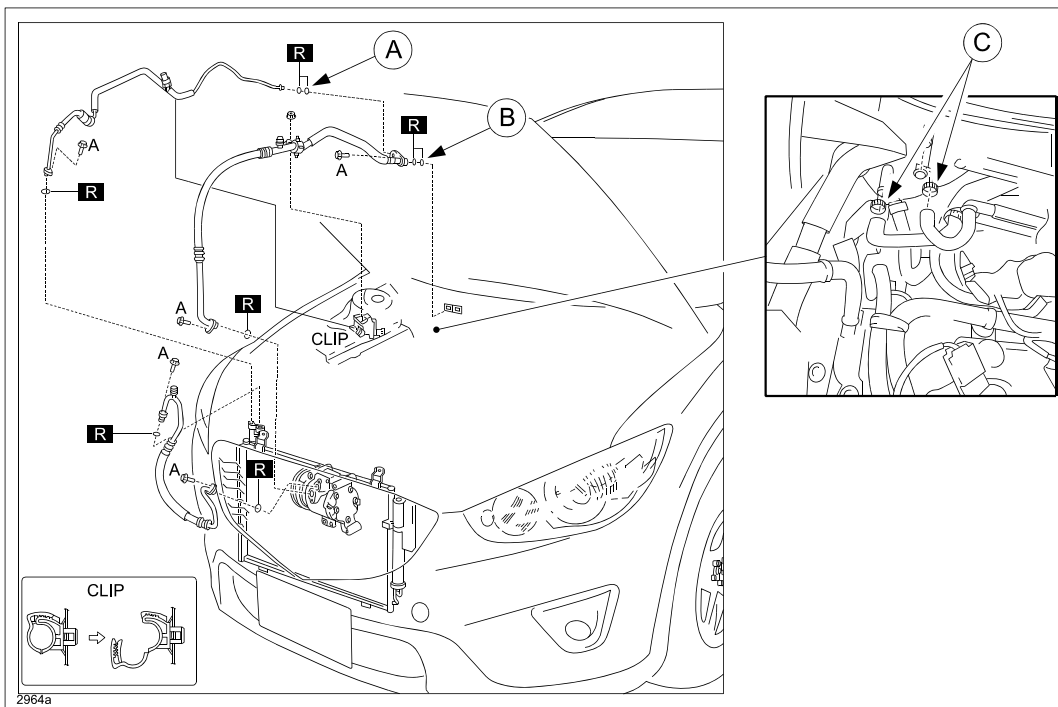
NOTE: Confirm the location of the replacement parts in the following figure.

Part Number	Description	Qty.	Notes
KD45-61-J10	Evaporator	1	CX-5
GHP9-61-J10	Evaporator	1	Mazda6 and Mazda3
GJ6A-61-J19	O-ring (Cooler Pipe)	1	A (Common for all models)
GJ6E-61-J19	O-ring (Expansion Valve)	1	A (Common for all models)
BBM4-61-J17	O-ring (Cooler Hose-Low and Expansion Valve)	2	B (Common for all models)
BP4K-61-242	Hose Clamp	2	C (Common for all models)
