Subject: NOISE FROM BOTTOM OF A-PILLAR	Bulletin No: 09-025/16
	Last Issued: 04/19/2016

APPLICABLE MODEL(S)/VINS

2014-15 Mazda3 (Japan built) with VINs lower than JM1BM*****230374 (produced before September 1, 2014)

2014-15 Mazda3 (Mexico built) with VINs lower than 3MZBM*****227448 (produced before May 29, 2015)

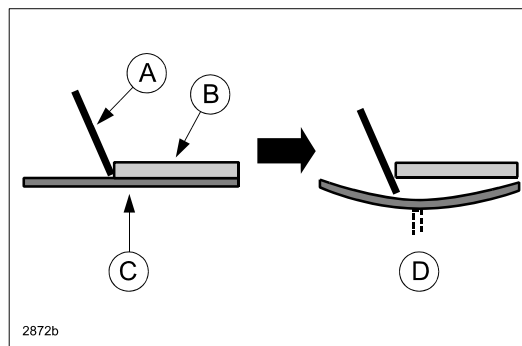
Locations to create clearance

- Areas A and B: Create a clearance for all vehicles
- Area C: Create a clearance for vehicles with VIN range JM1BM*****100001 - 189735

1. Verify customer concern.
2. Remove the hood from the vehicle according to the instructions on MS3 online or the Workshop Manual (section 09-10 HOOD REMOVAL/INSTALLATION).
3. Remove the cowl grille from the vehicle according to the instructions on MS3 online or the Workshop Manual (section 09-16 COWL GRILLE REMOVAL/INSTALLATION).
4. Place the tip of a covered* flat-blade screwdriver (A) between the wiper bracket (B) and the dash upper panel/cowl upper plate (C) and hit the head of the screwdriver with a hammer to create a clearance of approximately 0.5 mm (D) between the two.

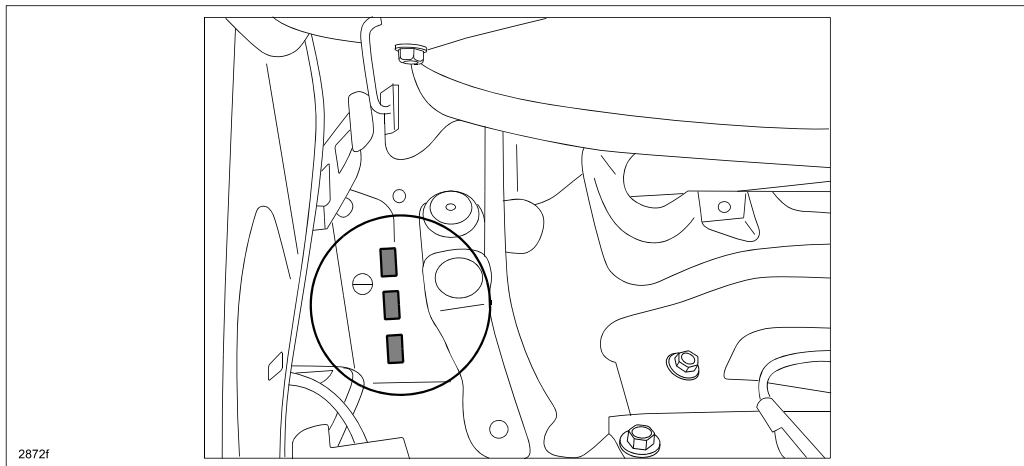
Area C for vehicles with VIN range JM1BM*****100001 - 189735

NOTE: It is not necessary to perform this repair on Mexico built veicles.
