© 2016 Mazda Motor of America, Inc.

Subject: POPPING AND/OR SQUEAKING NOISE FROM FRONT SHOCK ABSORBER AND/OR CREAKING NOISE FROM FRONT LOWER ARM BUSHING	Bulletin No: 02-001/16
	Last Issued: 02/23/2016

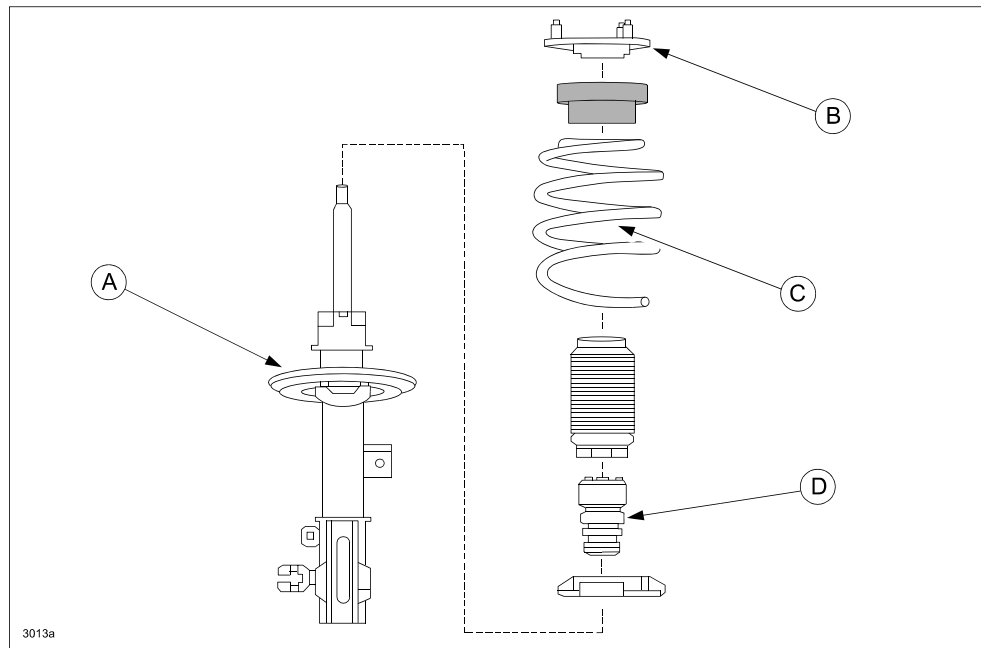
- A squeaking noise from the front shock absorber when turning the steering wheel at a vehicle standstill caused by stick-slip between the front strut bearing and the coil spring.
- A popping noise from the front shock absorber when passing over speed bumps caused by the bump stopper contacting the strut bearing when the shock absorber is compressed.
- **A creaking noise from the lower arm when driving over road bumps at 20-40 km/h caused by stick-slip of the front lower arm bushing. The noise occurs when the road surface is wet or after a car washing, and becomes more noticeable as the speed bump gets higher.**

1. Replace the bump stopper with the modified one according to MS3 online instructions or the Workshop Manual (section 02-13 FRONT SHOCK ABSORBER AND COIL SPRING DISASSEMBLY/ASSEMBLY).

- Before removing the mounting rubber, mark its original position so it can be re-installed later to the same position.
- When replacing the bump stopper with a modified one, apply grease to upper side of the bump stopper and to the inside of the bump stopper (on the surface that contacts the damper rod).

CAUTION: It is not necessary to adjust the front wheel alignment because the front shock absorber and mounting rubber are not being replaced. However, make sure to install the mounting rubber to the original position.
