Subject: POPPING NOISE THROUGH SPEAKER WHEN OPERATING POWER WINDOWS	Bulletin No: 09-011/15
	Last Issued: 04/13/2015

APPLICABLE MODEL(S)/VINS

2014-2015 Mazda3 (Japan built) vehicles (with BOSE audio) with VINS lower than JM1BM*****259081 (produced before February 2, 2015)

2014-2015 Mazda3 (Mexico built) vehicles (with BOSE audio) with VINS lower than 3MZBM*****182009 (produced before January 1, 2015)

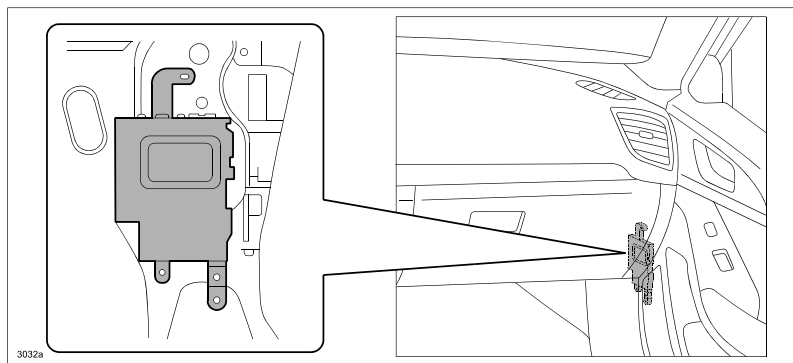
Some vehicles may experience a popping noise coming from the speaker(s) when operating the power window master switches at the driver's door. This is caused by insufficient noise suppression in the Tuner Amp Unit (TAU). To correct the problem, the internal noise suppressor in the TAU has been changed.

1. Verify customer concern.
2. Remove the TAU and replace with a modified one according to the instructions on MS3 online or the Workshop Manual (section 09-20 TUNER AND AMP UNIT (TAU) REMOVAL/INSTALLATION).
