Subject: REAR CONSOLE LID DOES NOT LATCH (BROKEN LATCH)	Bulletin No: 09-012/15
	Last Issued: 04/17/2015

APPLICABLE MODEL(S)/VINS

2014-2015 Mazda3 (Japan built) vehicles with VINS lower than JM1BM*****227327 (produced before August 1, 2014)

2014-2015 Mazda3 (Mexico built) vehicles with VINS lower than 3MZBM*****157427 (produced before October 6, 2014)

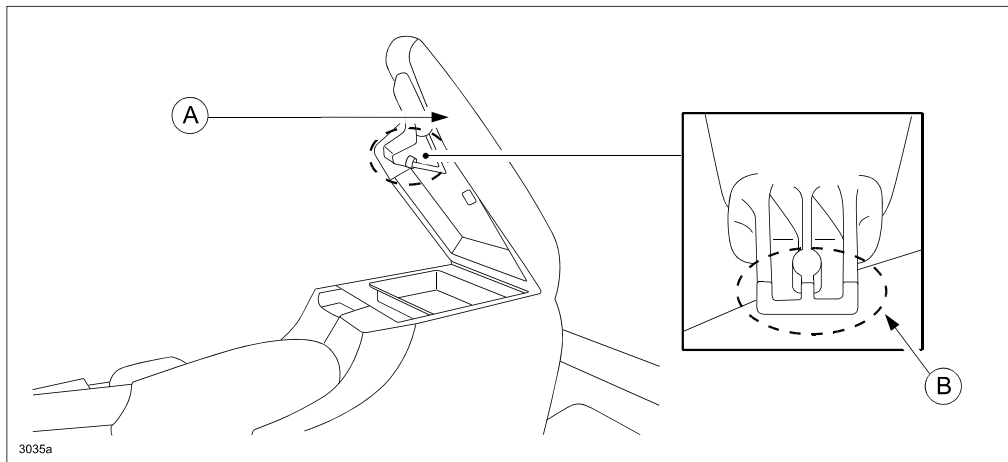
Some vehicles may exhibit the rear console lid (A) not being able to latch due to a broken latch (B).

The latch may be broken by excessive external force applied to the lid. To correct the problem, the rear console lid latch has been changed to increase the strength.

1. Verify customer concern.
2. Replace the rear console lid assembly with a modified one according to the instructions on MS3 online or the Workshop Manual (section 09-10 REAR CONSOLE DISASSEMBLY/ASSEMBLY).
3. Verify repair.
