© 2015 Mazda Motor of America, Inc.

Subject: REAR CONSOLE LID IS LOOSE	Bulletin No: 09-023/15
	Last Issued: 12/14/2015

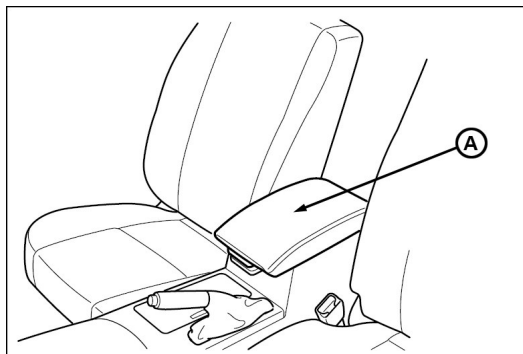
Some customers may complain about a loose rear console lid (A).

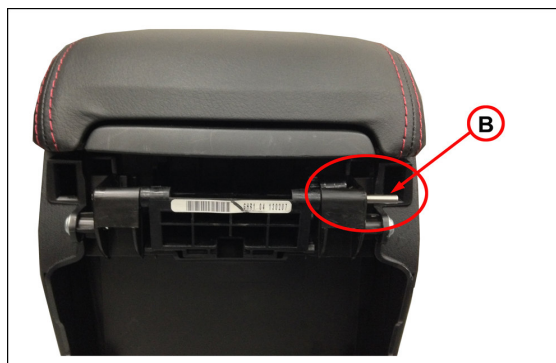
This may be caused by hinge pins coming partially off (B) or completely off.

Customers having this concern should have their vehicle repaired using the following repair procedure.

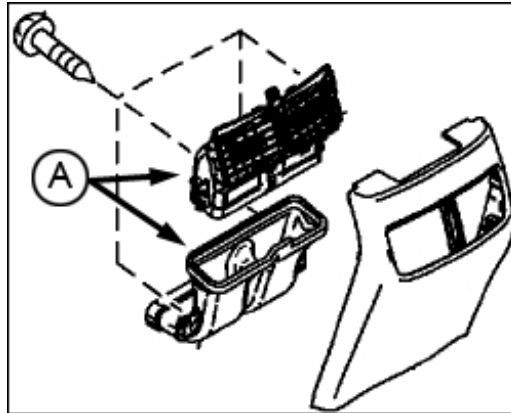
NOTE: The shape of the rear console panel has been changed, by adding a stopper rib to prevent the pin from coming off.

5. Mazda6 with ventilation, install a new rear console panel (see PART(S) INFORMATION) and reuse the rear and front ducts (A).
