Subject: RUST ON UNDERCARRIAGE	Bulletin No: 00-004/15
	Last Issued: 11/17/2015

APPLICABLE MODEL(S)/VINS

2015 Mazda3 (Mexico built) vehicles with VINs starting with 3MZ (see attached VIN list)

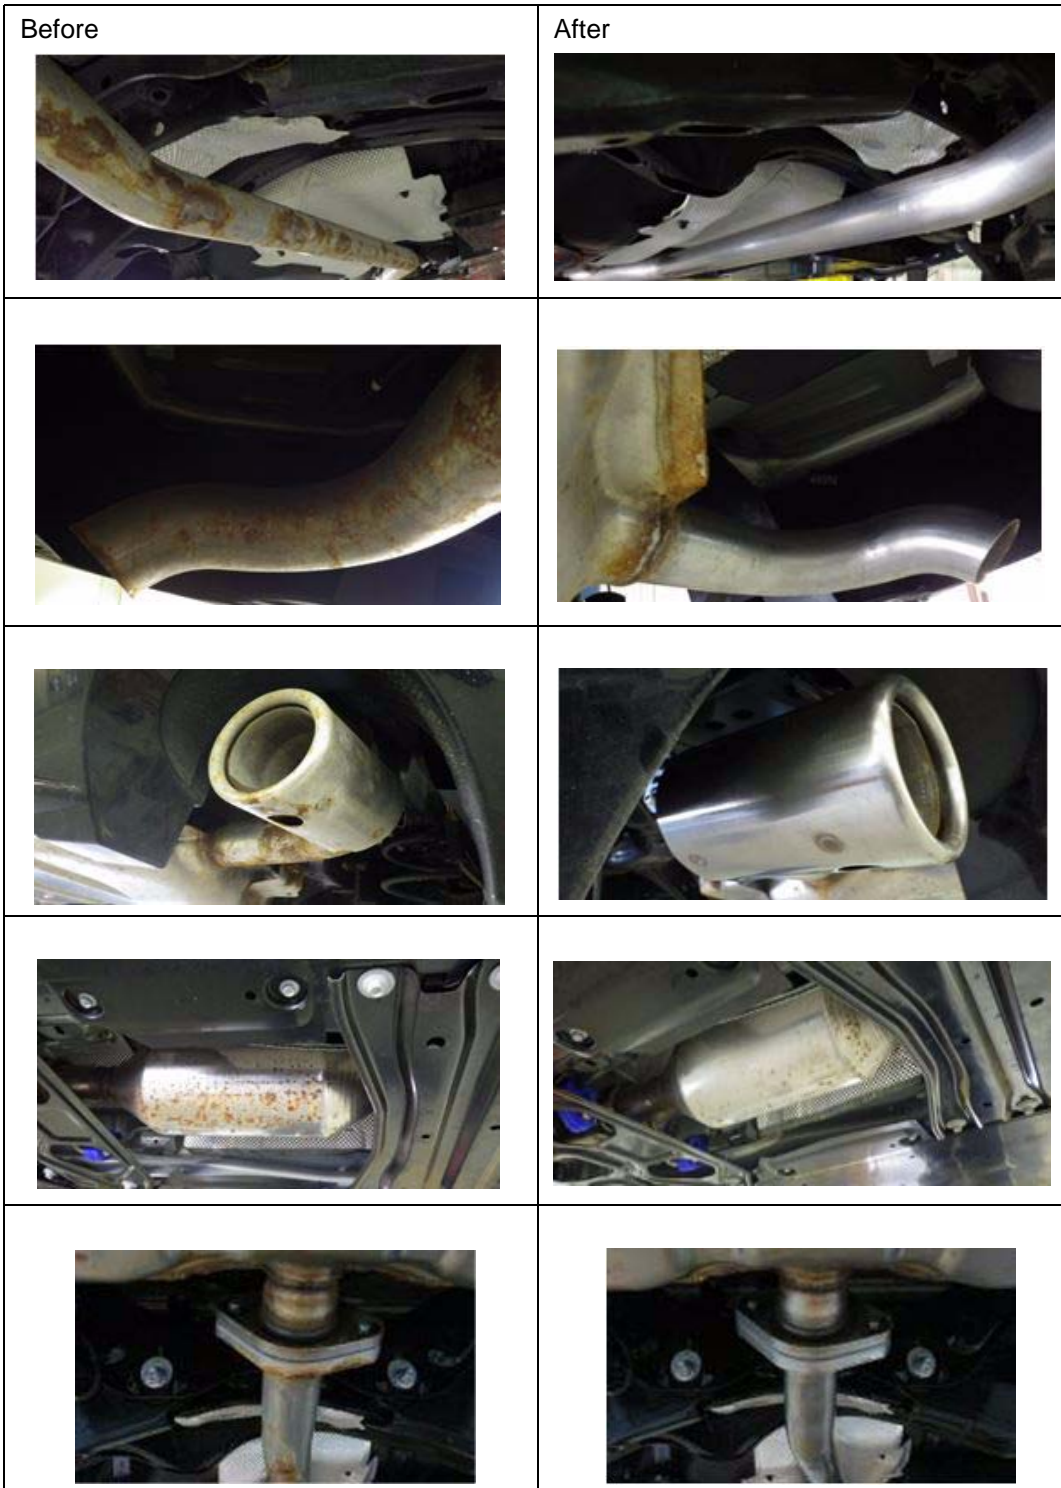
Some vehicles that were held in Port Veracruz may exhibit surface rust on the undercarriage. Port Veracruz is at the southern part of Mexico, facing the Gulf of Mexico. This area is known for very harsh environmental conditions such as extremely hot conditions, acid rain, strong winds and heavy rainfall. The combination of these natural elements can result in surface rust to the exterior chrome moldings and metal undercarriage components.

1. Verify customer concern and confirm that customer's vehicle is on the attached VIN list.
2. Raise vehicle completely in air to clean and seal undercarriage
3. Using a semi-rough scrub pad, remove any surface rust/rust from the entire (top, bottom and sides) exhaust system. Wipe the exhaust with clean paper towel. If the vehicle is equipped with chrome exhaust tip(s), use a soft/fine scrub pad and remove the rust from them. Using the same pad, clean any rust from inside the exhaust tip. Using a large wire brush, clean the flange between the rear silencer and the front exhaust pipe.

NOTE: DO NOT use Rust Fix on the exhaust system.
