<b>Subject:</b>  SIDE(S) OF REAR SEAT CUSHION IS LIFTING OR LOOSE	<b>Bulletin No:</b> 09-024/14
	<b>Last Issued:</b> 08/15/2014

2014-15 Mazda3 vehicles

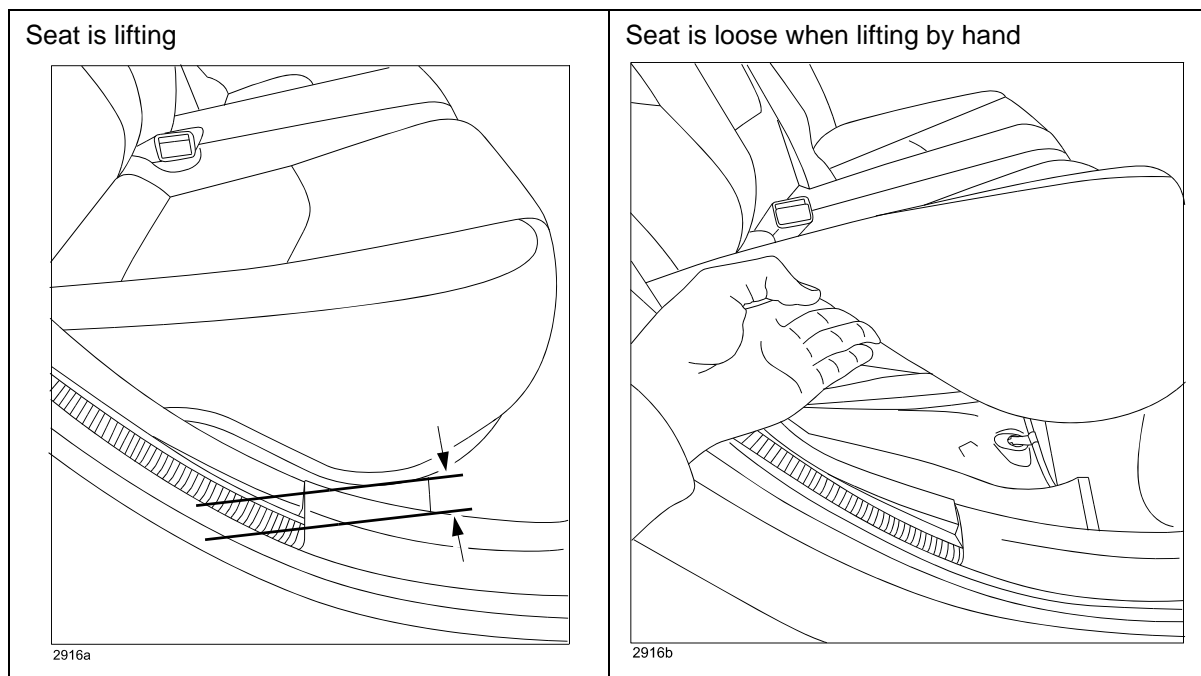
Some customers may complain that the side(s) of the rear seat is lifting or loose when lifted by hand.

This is caused by a product variation of the rear seat cushion. Some cushions may have a larger clearance between the cushion and the floor carpet.

Customers having this concern should have their vehicle repaired using the following repair procedure. When you receive a customer complaint on this concern, fix both sides of the rear seat cushion to the carpet using Velcro tape.
