Subject: UNUSUAL NOISE WHEN STARTING TO MOVE VEHICLE WHILE STEERING WHEEL IS TURNED TO FULL LEFT POSITION	Bulletin No: 06-002/14
	Last Issued: 07/29/2014

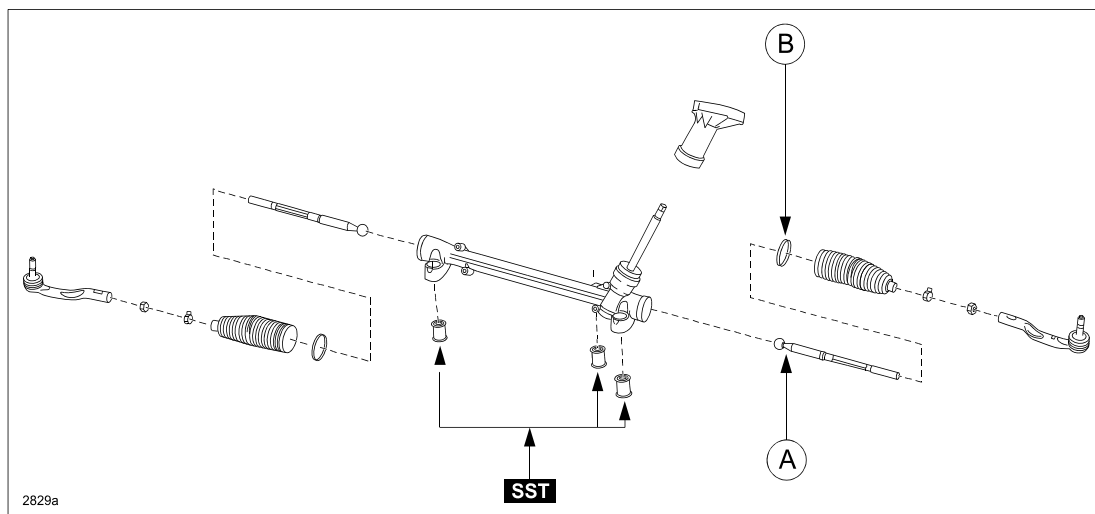
The noise is caused when the edge of the left side inner ball joint (A) gets stuck with the steering gear housing. The following modifications have been made to eliminate the noise:

1. The shape of the inner ball joint edge has been changed.
2. Grease has been applied to the inner ball joint edge.

Customers having this concern should have their vehicle repaired using the following repair procedure.
