<b>Subject:</b> VARIOUS AUDIO SYSTEM CONCERNS WITH TUNER AND AMP UNIT (TAU)	<b>Bulletin No:</b> 09-021/14
	<b>Last Issued:</b> 06/27/2014

2014 Mazda3 vehicles (with MAZDA CONNECT) with VINs lower than JM1BM\*\*\*\*\*194012 (produced before March 17, 2014)

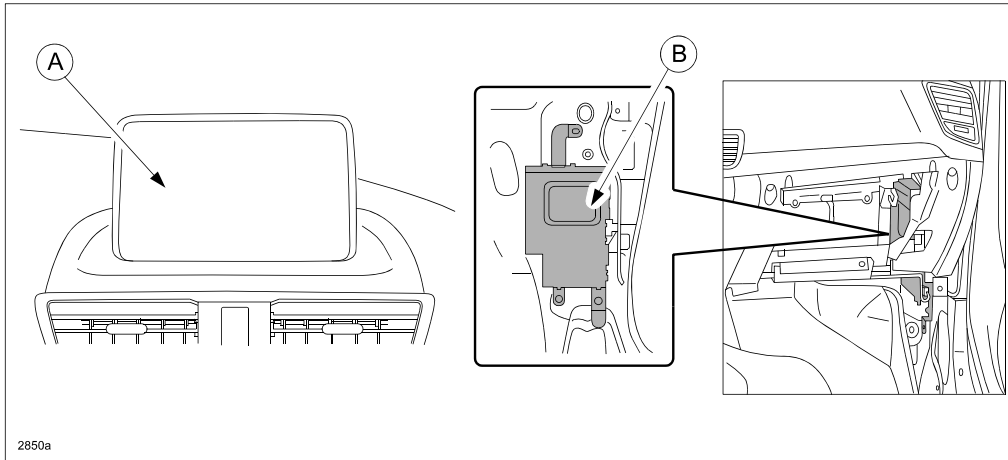
Some vehicles with TAU version below "3030 1903" may experience any one of the symptoms below that can be resolved with a modified TAU.

- AM/FM/XM cannot be selected as they are grayed out
- Radio station returns to 87.9MHz on its own
- Audio sound setting resets on its own
- TAU version is displayed as "not available"
- Volume of FM stations changes while driving when there is poor reception

1. Verify customer concern.
2. On vehicle with a touchscreen (A), remove the TAU (B) and replace with a modified one. Refer to MS3 online instructions or Workshop manual (section 09-20 TUNER AND AMP UNIT (TAU) REMOVAL/INSTALLATION).
