<b>Subject:</b> <b>WHITE FELT VISIBLE FROM FRONT DOOR TRIM JOINT CAUSING POOR APPEARANCE</b>	<b>Bulletin No:</b> 09-042/14
	<b>Last Issued:</b> 09/26/2014

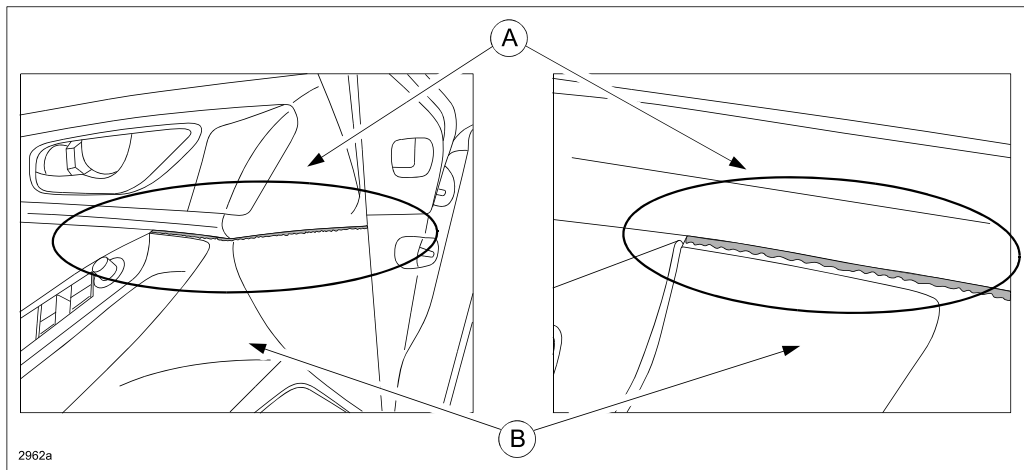
Some vehicles may exhibit a white felt (used for noise insulation) visible through the gap between the upper (A) and lower (B) front door trim, causing a poor appearance.

The cause of this is that the color of the felt and the glue is not appropriate and highly visible. To correct the problem, the color of the felt and the glue has been changed to one that resembles the door trim. The production control and the inspection have also been improved to eliminate the protruding felt.

1. Verify customer concern.
2. Replace the concerned front door trim with a modified one according to the instructions on MS3 online or the Workshop Manual (section 09-17 FRONT DOOR TRIM REMOVAL/INSTALLATION).
3. Verify repair.
