Subject: WRINKLES ON LEATHER SEAT SURFACE OF NEW VEHICLE	Bulletin No: 09-016/16
	Last Issued: 03/07/2016

DESCRIPTION

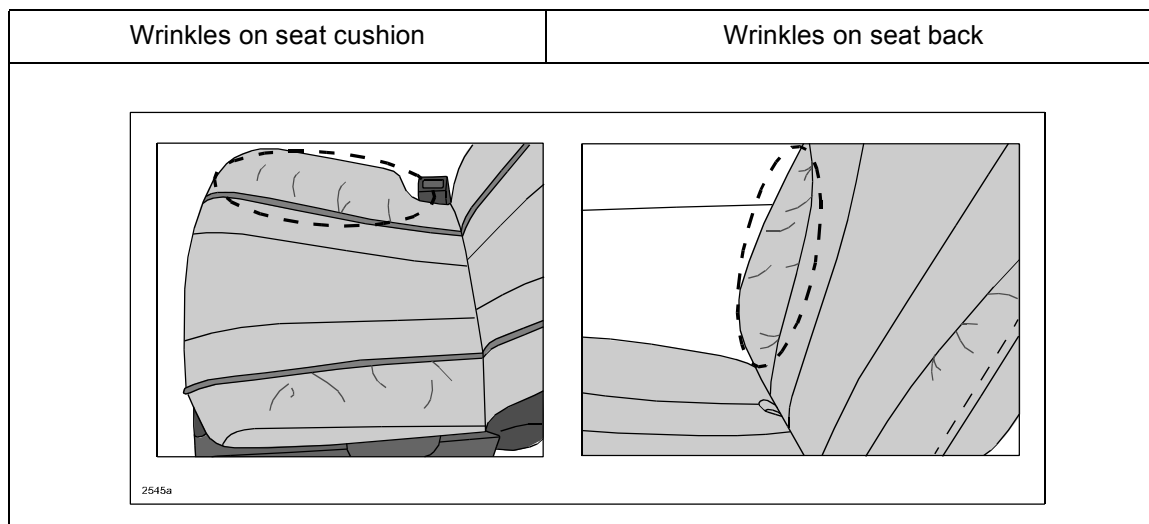
At PDI or when new vehicle is delivered, some customers may complain about wrinkles on the leather seat cushion and/or seat back surface.

Customers having this concern should have their vehicle repaired by a qualified upholstery repair specialist using the following repair procedure.

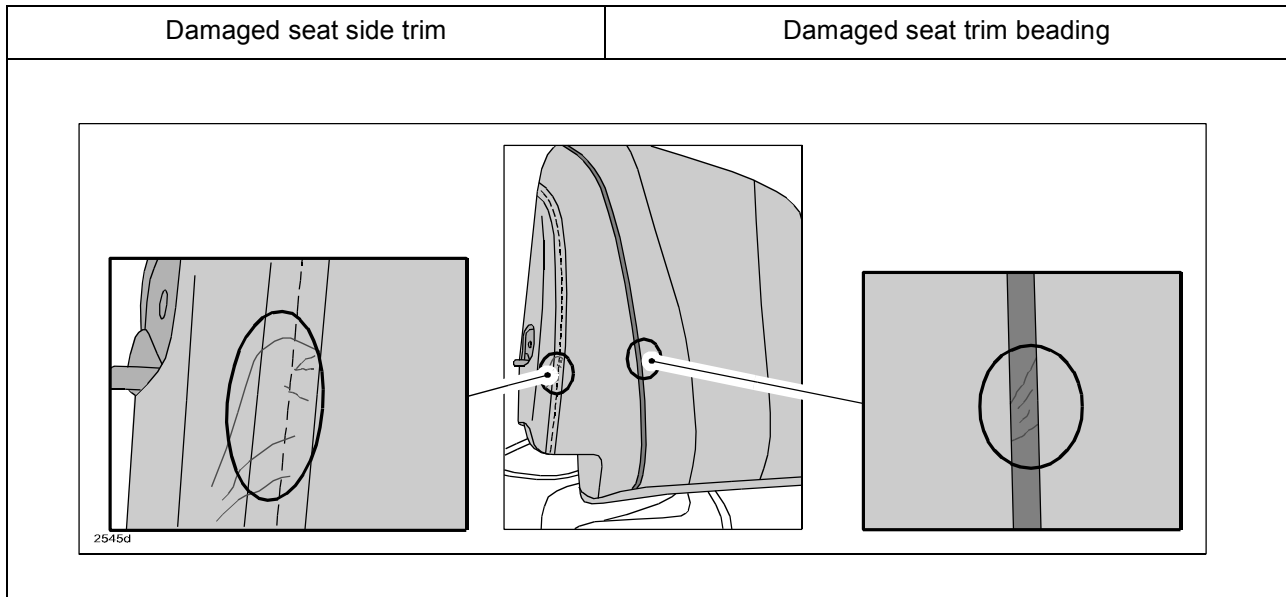
- Do NOT keep the steamer head at the same place for a long time.
- Do NOT run the steamer head without a water-soaked cloth especially over seat trim beading and seat side trim area.
- Seat damage may occur if the caution points above are not followed as shown below.
