Service Information

Mazda Motor Corporation

Category T	Technical	Ref. No. E028/13B	Page 1 of 3
Coverage <input type="checkbox"/> Distributor only <input checked="" type="checkbox"/> Please inform your dealers		Date Issued November 29, 2013	
Please convey this information to your <input checked="" type="checkbox"/> Warranty Dept. <input checked="" type="checkbox"/> Parts Dept. <input type="checkbox"/> Direct <input type="checkbox"/> Training Dept. <input checked="" type="checkbox"/> General Manager <input checked="" type="checkbox"/> Field Rep.		Date Revised April 24, 2017	
Applicable Model Mazda3 (BM), Mazda2 (DJ), CX-3 (DK), Mazda6 (GJ): with Active Driving Display	Applicable Countries or Specifications Worldwide

Subject: Handling Caution of Active Driving Display (ADD)

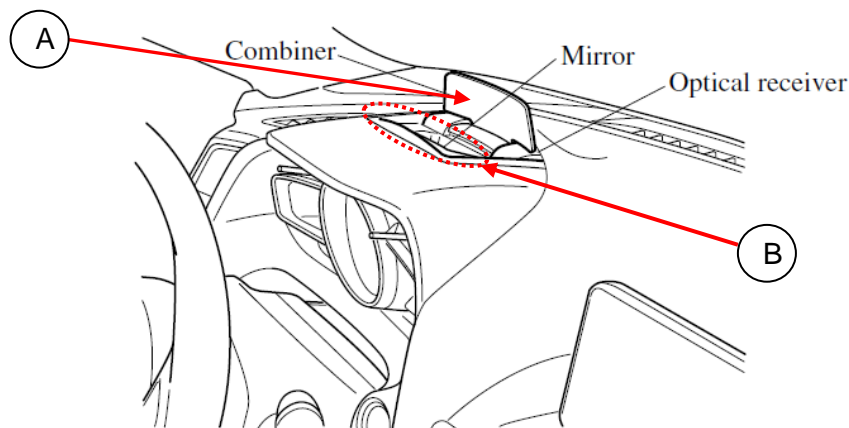
The zero-point (close position) of the (A) ADD combiner may have been incorrectly learned due to an object which was placed in the (B) storage area of the ADD combiner.

- NOTE:** (A) DO NOT force to close/open it manually.
(B) DO NOT place papers, gloves etc. here.

1. Turn the ignition to OFF.
2. Remove and then install the ROOM FUSE.
3. Start the engine.
4. Learning of the zero-point is automatically performed.
