Subject: NOISE FROM BOTTOM OF A-PILLAR	Bulletin No: 09-025/16
	Last Issued: 04/19/2016

APPLICABLE MODEL(S)/VINS

2014-15 Mazda3 (Japan built) with VINs lower than JM1BM*****230374 (produced before September 1, 2014)

2014-15 Mazda3 (Mexico built) with VINs lower than 3MZBM*****227448 (produced before May 29, 2015)

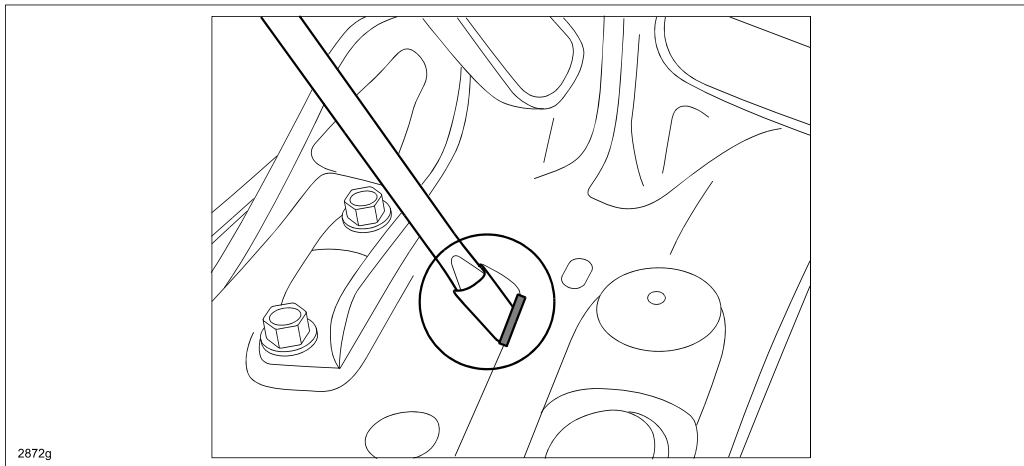
Area C for vehicles with VIN range JM1BM*****100001 - 189735

NOTE: It is not necessary to perform this repair on Mexico built veicles.

5. Apply a body adhesive to Area A between the wiper bracket and the dash upper panel (at the two locations shown).
