Subject: RUST ON UNDERCARRIAGE	Bulletin No: 00-004/15
	Last Issued: 11/17/2015

APPLICABLE MODEL(S)/VINS

2015 Mazda3 (Mexico built) vehicles with VINs starting with 3MZ (see attached VIN list)

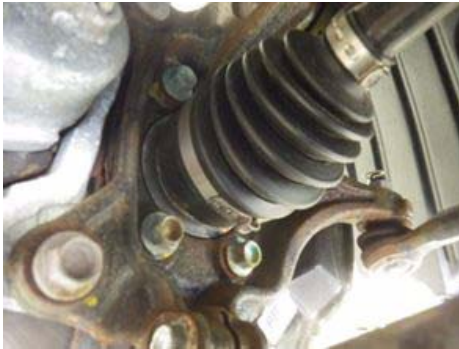
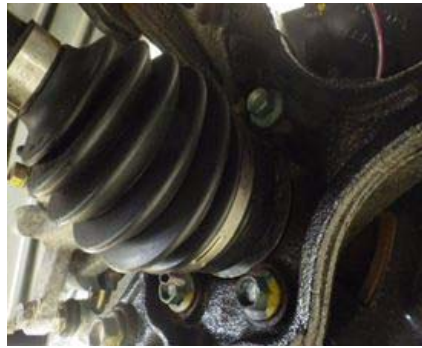
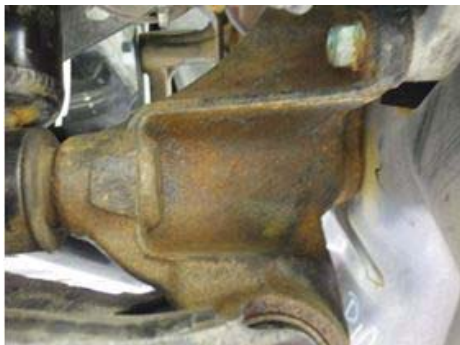
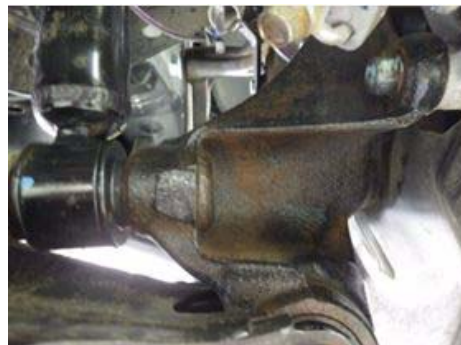
Some vehicles that were held in Port Veracruz may exhibit surface rust on the undercarriage. Port Veracruz is at the southern part of Mexico, facing the Gulf of Mexico. This area is known for very harsh environmental conditions such as extremely hot conditions, acid rain, strong winds and heavy rainfall. The combination of these natural elements can result in surface rust to the exterior chrome moldings and metal undercarriage components.

- Using a large wire brush, clean the sub frame mounting bolt area of surface rust. Apply rust fix spray to the sub frame mounting bolt area after cleaning. Visually inspect for any other concerned areas such as the bottom of the mounting area of the shocks, the bottom area of the strut spring support, etc. If any other concerns are identified, clean them using a wire brush or "Scotch-Brite" pad and apply rust fix afterwards.
