Subject: WRINKLES ON LEATHER SEAT SURFACE OF NEW VEHICLE	Bulletin No: 09-016/16
	Last Issued: 03/07/2016

DESCRIPTION

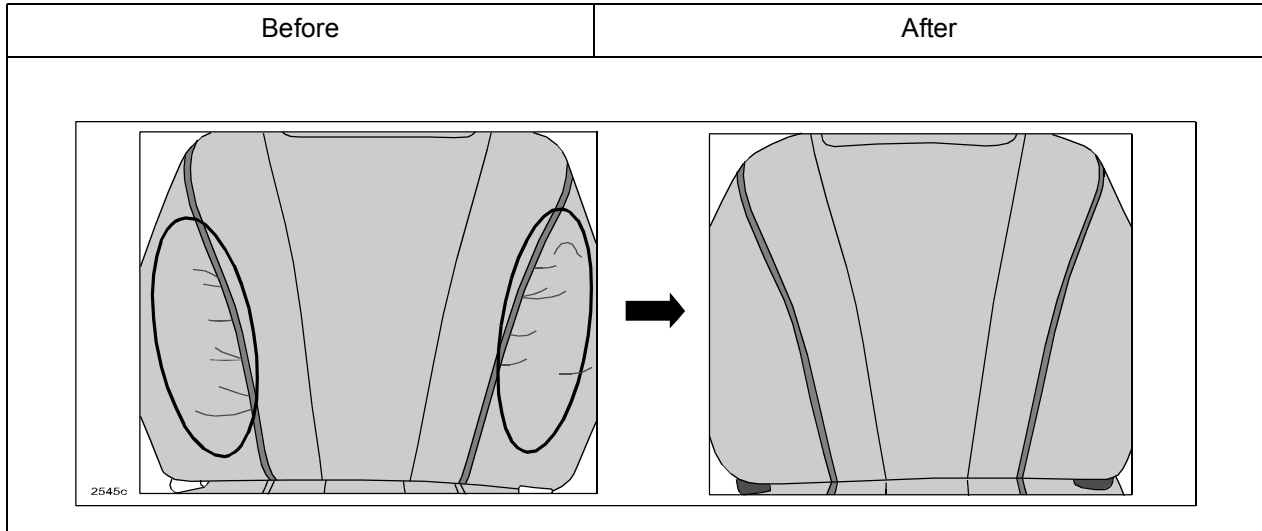
- Do NOT keep the steamer head at the same place for a long time.
- Do NOT run the steamer head without a water-soaked cloth especially over seat trim beading and seat side trim area.
- Seat damage may occur if the caution points above are not followed as shown below.

3. Repeat step #2 until the wrinkles are removed to an acceptable level.

NOTE: Direct heat may be necessary to aid in the removal of some wrinkles. Refer to HEAT GUN METHOD.
